YEAR 7 (2007)
MITIGATION/MONITORING REPORT
FOR
RIPARIAN IMPACTS ASSOCIATED WITH THE
RUBINO DEVELOPMENT PROJECT
SAN JOSE, CALIFORNIA

May 2007

SITE PHOTOGRAPHS (Spring 2007)

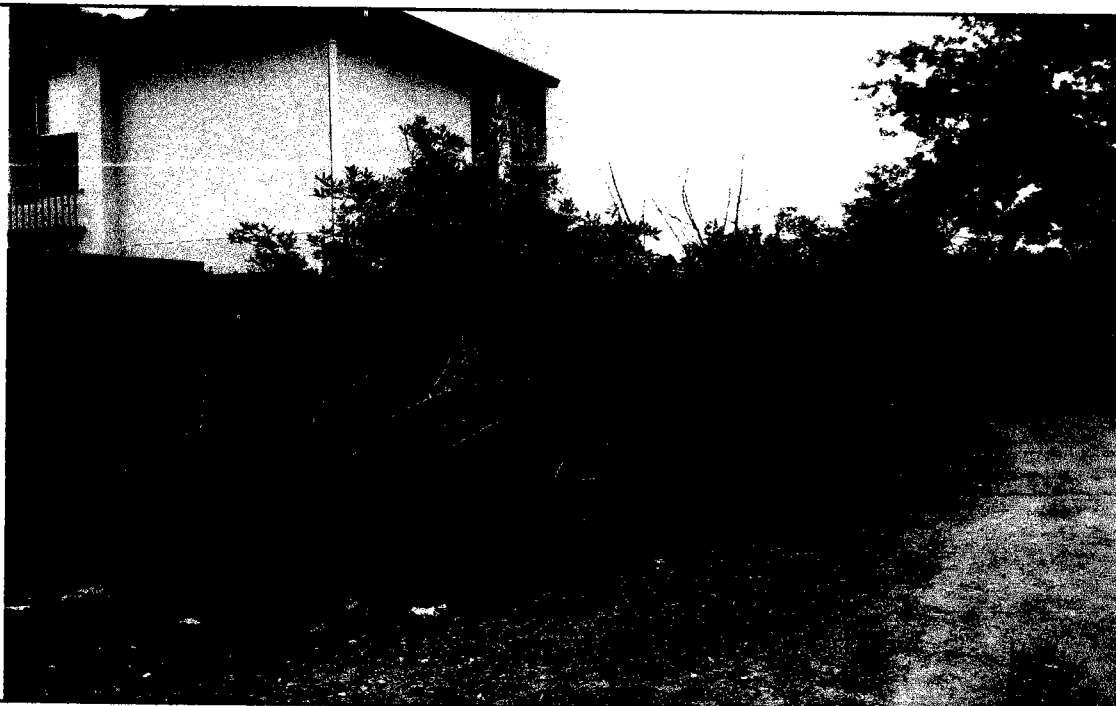
Photo No. 1. April 2007. Southern view of Rubino Restoration site along the east side of the Guadalupe River. Toyon shrubs look full and healthy.

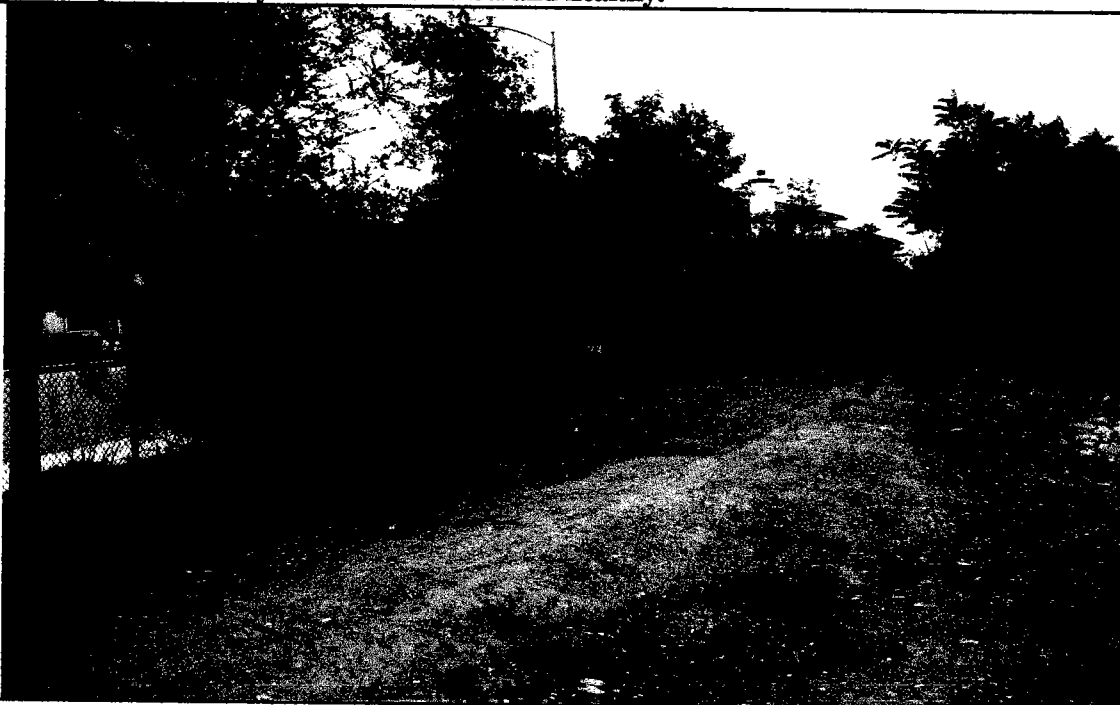
Photo No. 2. April 2007. Southern view of Rubino Restoration site along the east side of the Guadalupe River west of Sunbonnet Loop.

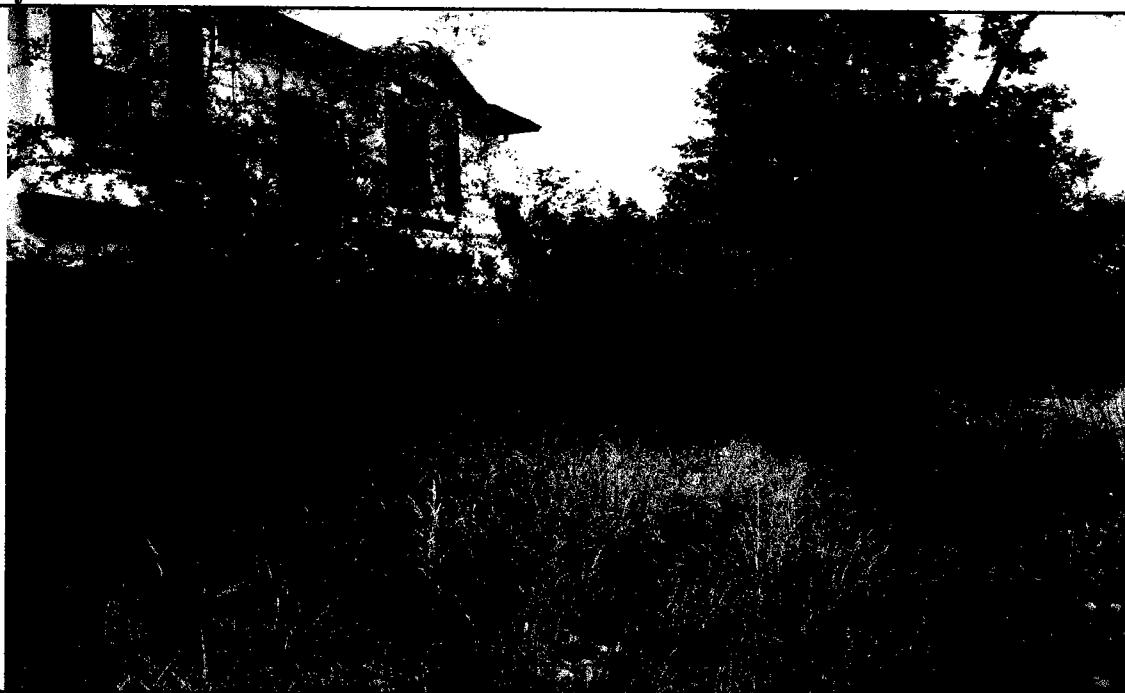
Photo No. 4. April 2007. Southern view of Rubino Restoration site along east Guadalupe River. Restoration area between Sunbonnet and McBride Loop.

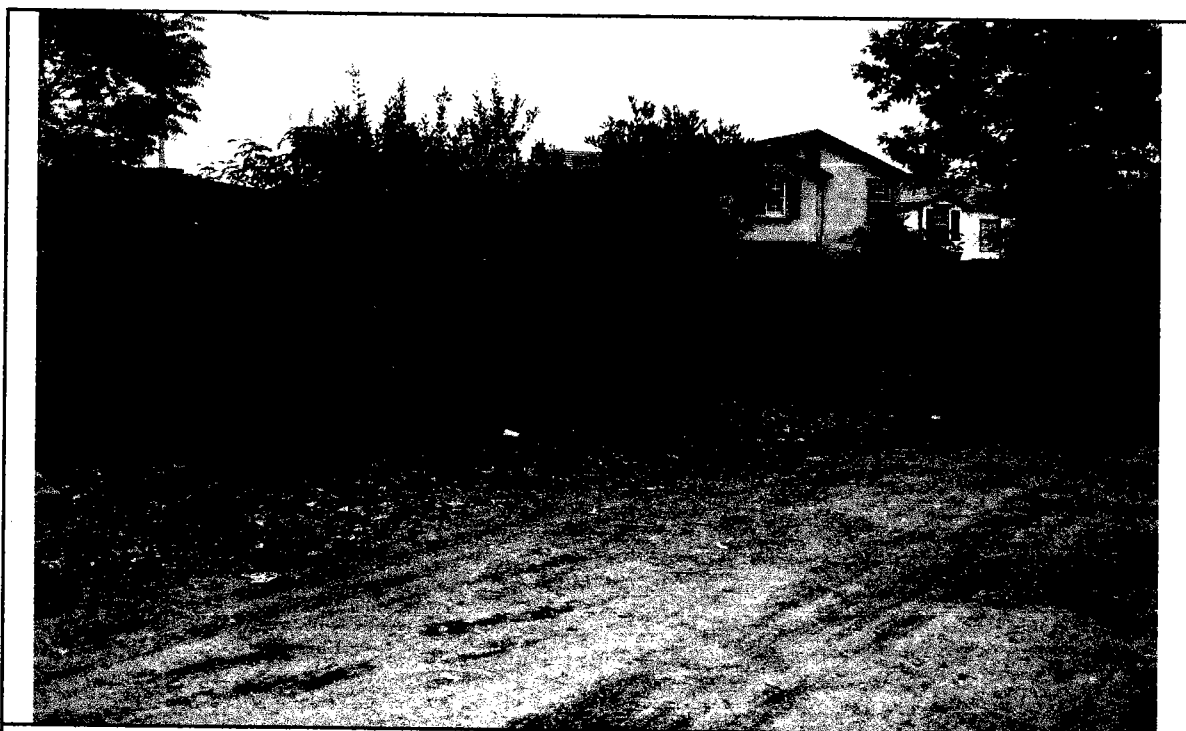
Photo No. 5. April 2007. Southern view of restoration site east of Guadalupe River and west of McBride Loop.

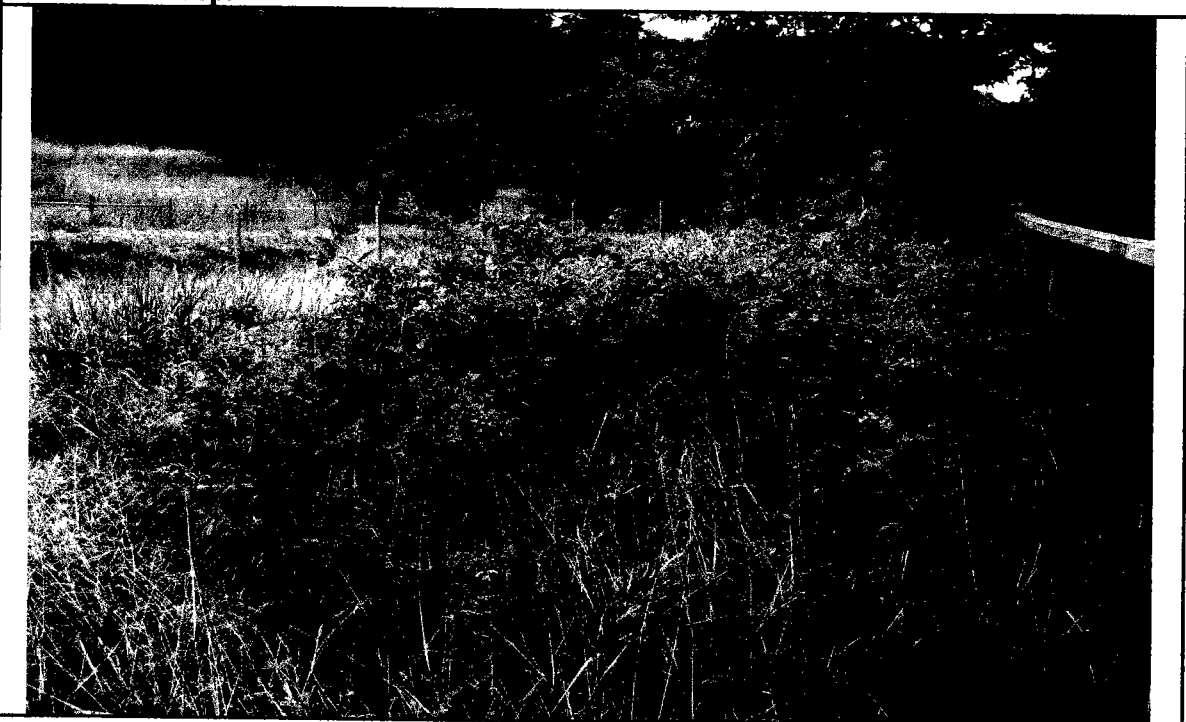
Photo No. 6. April 2007. Southern view of Rubino Restoration site along the west side of Canoas Creek.

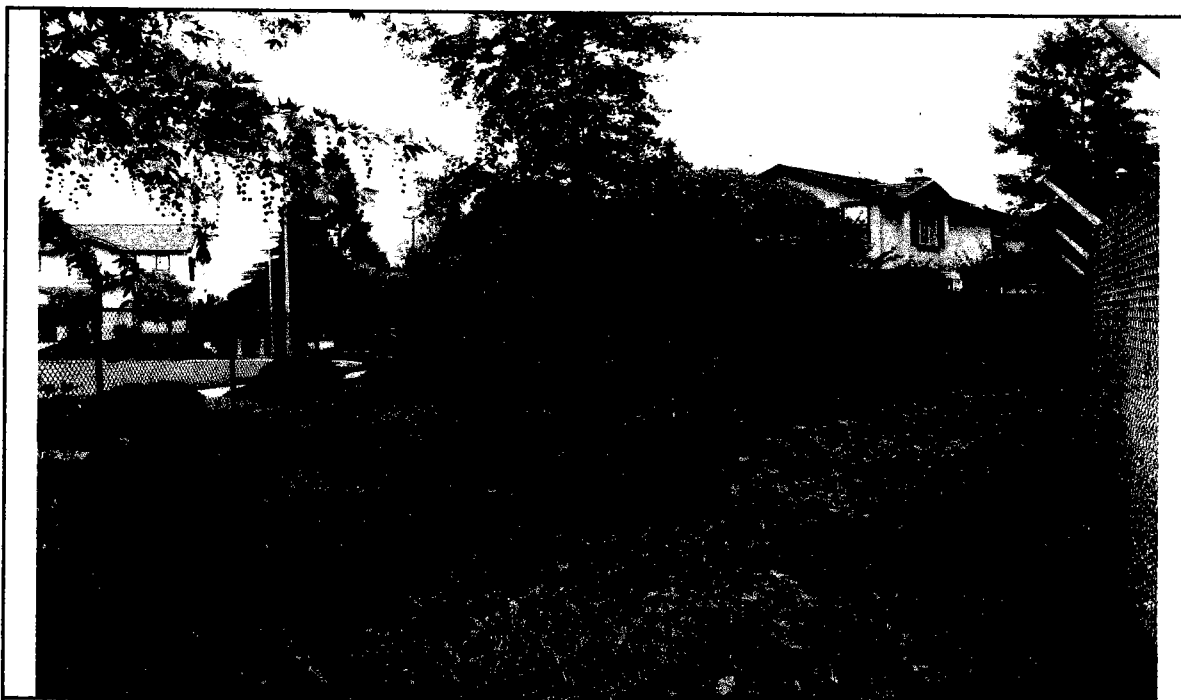
Vegetative cover by weed species was 100 percent throughout the Restoration site (See Attachment 2). Based on the height and amount of weed species on the site, it appears that maintenance crews have not been out to weed the site or check irrigation lines for some time. Slight overspray of herbicides intended for invasive weed species was, again, observed to have negative impacts on the blackberry, snowberry, and coffeeberry shrubs lining the fence along Canoas Creek. Several shrubs, especially the toyon, flannel bush, and snowberry, appear to be drying out due to lack of water along the Guadalupe River and Canoas Creek.

Photo No. 7. April 2007. Northeastern view of the Rubino Restoration site along the west side of Canoas Creek north of Atkin Loop. Weed growth is heavy along Canoas Creek.

- < All workers who conduct weeding must be educated to differentiate between weed species and the restoration stock. Workers shall not pull weeds until they can determine the difference between weeds and restoration plants. This has been an ongoing problem since 2002.
- < A dense growth of weeds was recorded in several areas of the mitigation site, especially along the Canoas Creek corridor. These weeds are competing with the mitigation plants for valuable resources in the planting bowls. Weeding needs to continue to be conducted

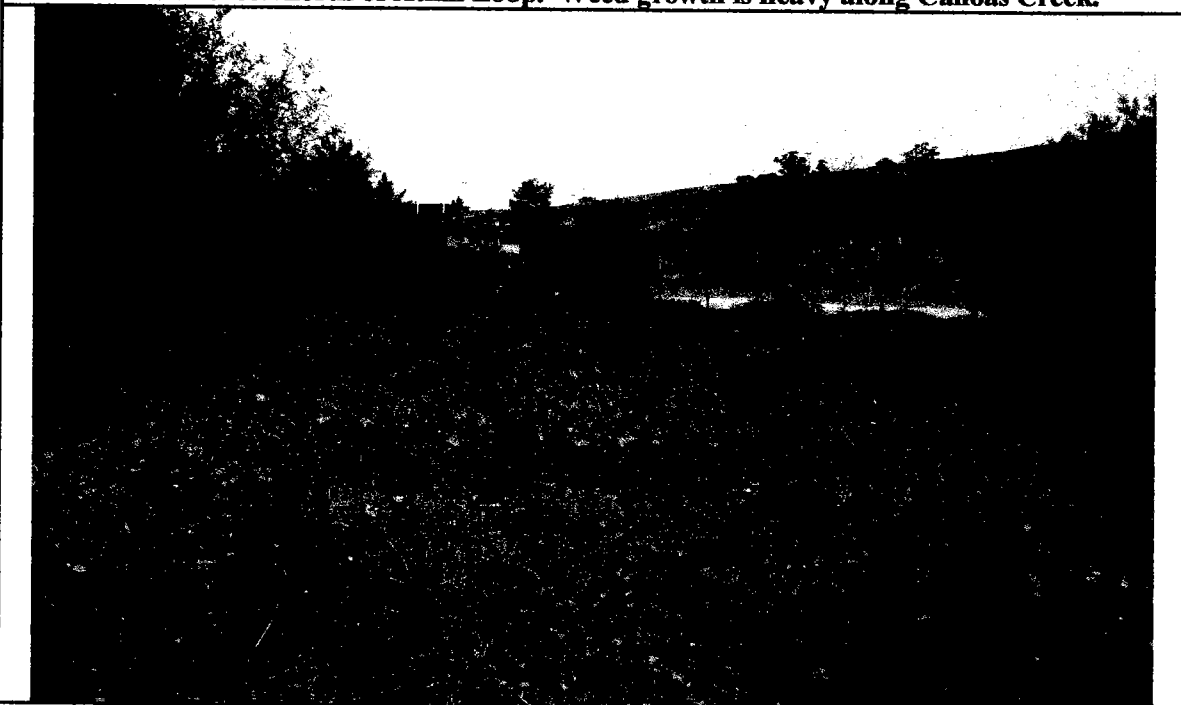
Photo No. 8. April 2007. Northern view of restoration site west of Canoas Creek and east of Atkin Loop. Large coffeeberry shrubs observed in background. Note the heavy weed growth throughout this section of the restoration site.

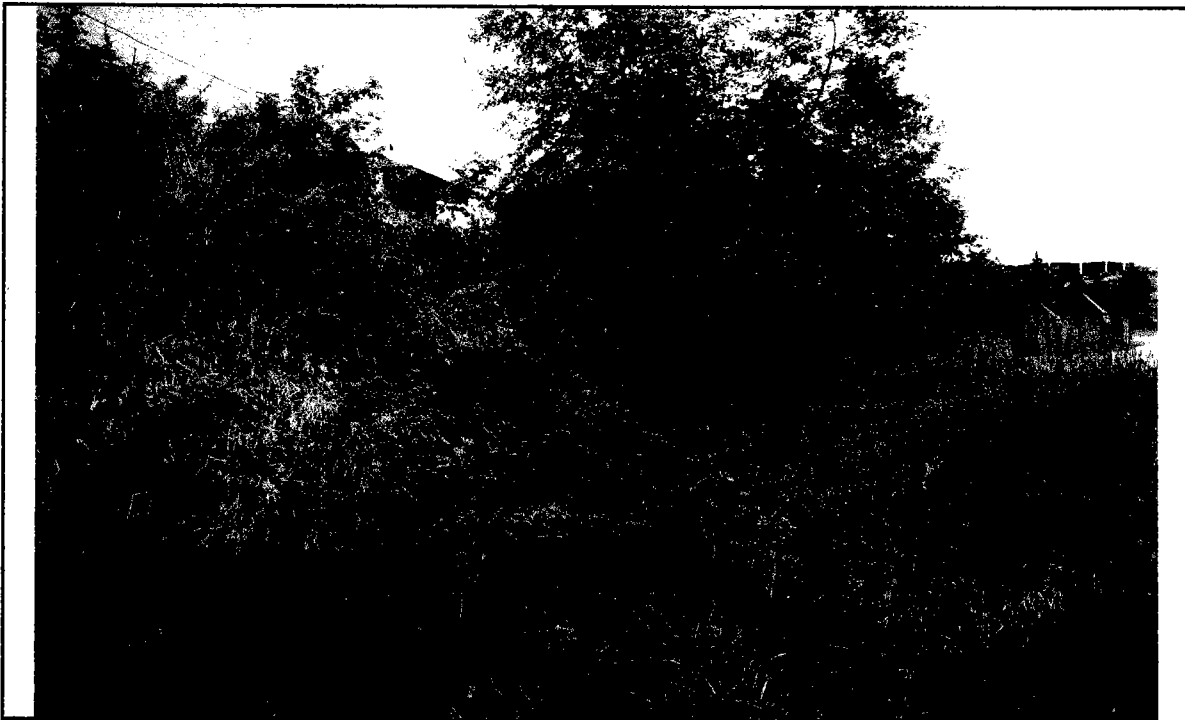
Photo No. 9. April 2007. Northern view of restoration site along west side of Canoas Creek east from Dederick Court.

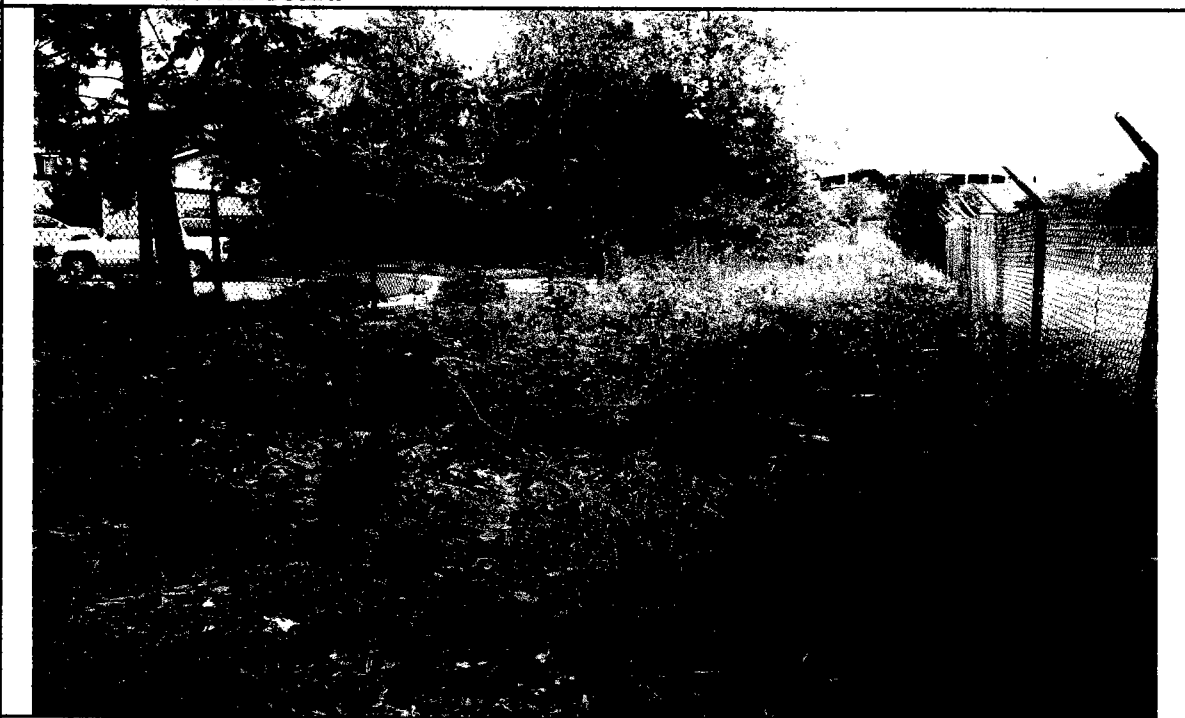
Photo No. 10. April 2007. Northern view of restoration area along west side of Canoas Creek east from Romani Court.

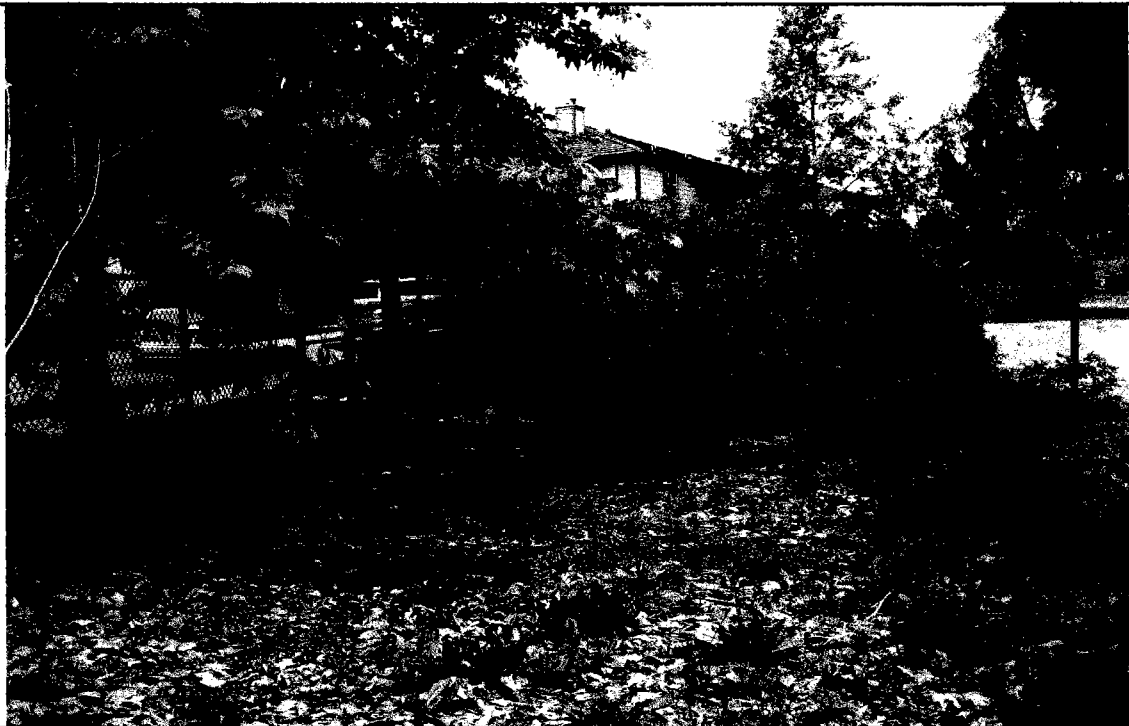
Photo No. 11. April 2007. Rubino Restoration Area viewed north from Brevins Loop. Large coffeeberry shrubs and California rose have grown to tall heights.

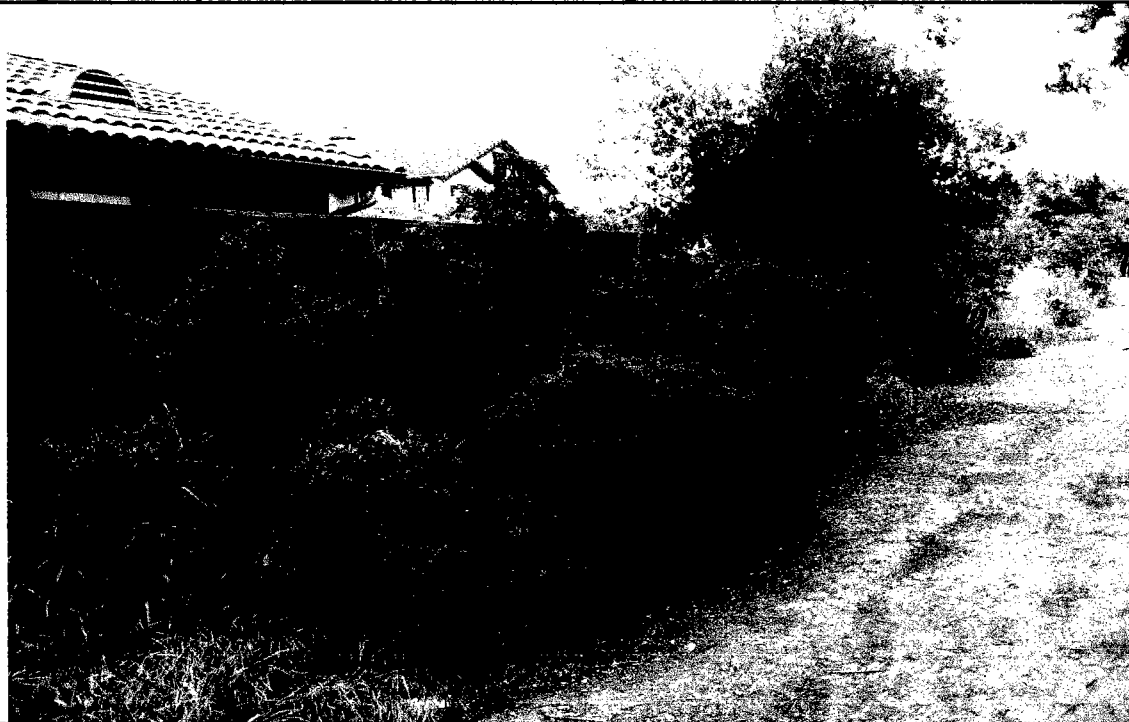
Photo No. 12. April 2007. Large size coffeeberry specimen exhibits excellent growth habitat.
